Manhole Inspection Summary

Manhole # S23MM_029MH

Insp Date: **9/18/07 11:32 AM**

Location Address: **2547 FRANCIS ST**

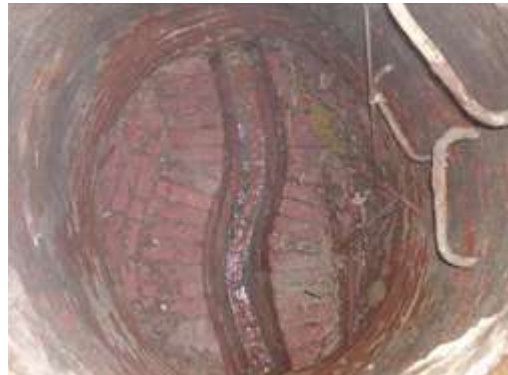
Top View

Corroded steps. Evidence of surcharge - Bench debris.

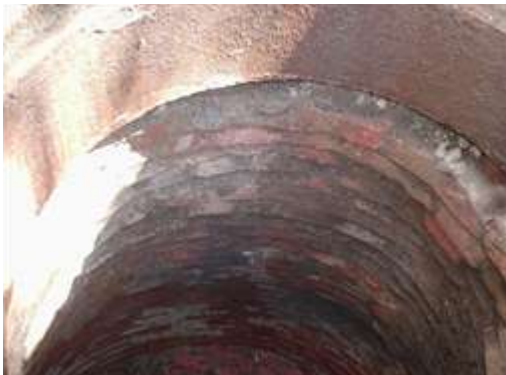
Defect

Frame leaks. Frame offset. Adjustment deterioration and infiltration. Corbel and Barrel infiltration.

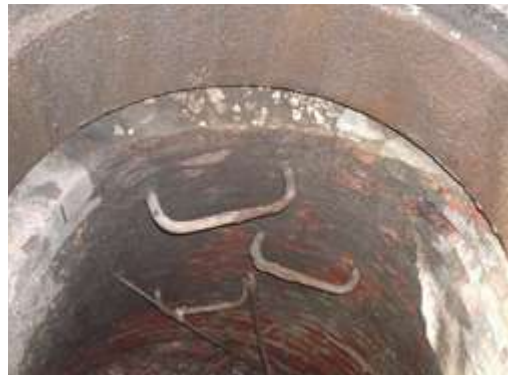
Defect

Frame leaks. Frame offset. Adjustment deterioration and infiltration.

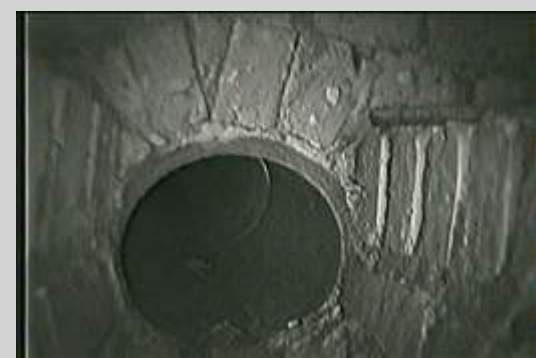
8 in. Circular Gravity Sewer Pipe Out @ 12 O'Clock

Infiltration: **Evidence** Pipe Seal Cond: **Unknown**

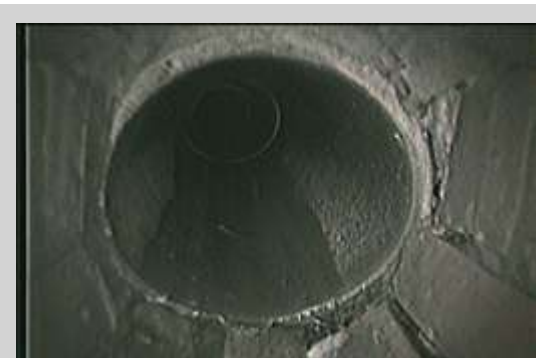
8 in. Circular Gravity Sewer Pipe In @ 6 O'Clock

Channel deterioration.

Infiltration: **Evidence** Pipe Seal Cond: **Cracked**
